**The Ridge
Federal Way, WA**

Report #: 20326-6
Beginning: January 1, 2024
Expires: December 31, 2024

**RESERVE STUDY
Update "With-Site-Visit"**

September 15, 2023

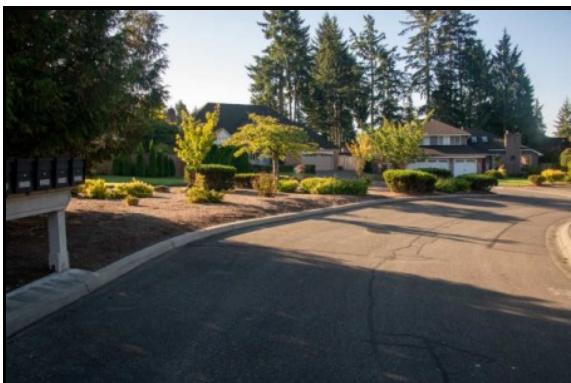
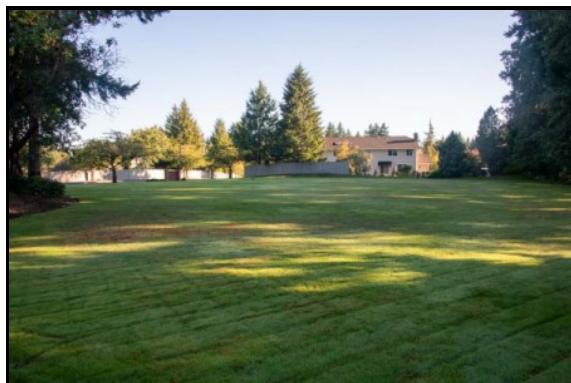
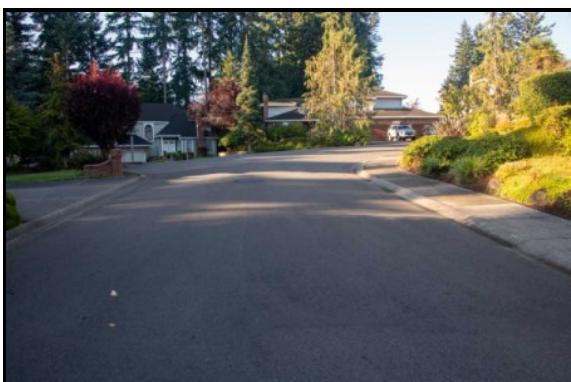
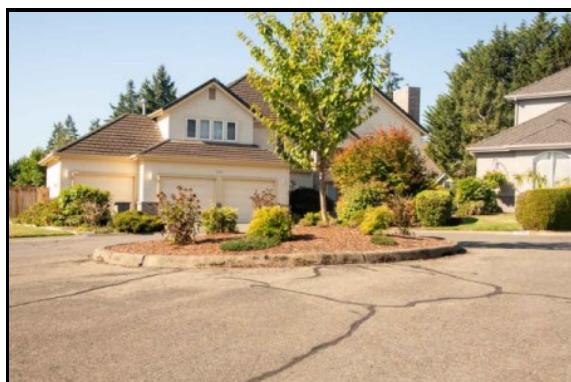
The overall community looks well cared for and appreciated by the homeowners. The yards and exterior appearance of homes is reflective of a well cared for neighborhood. The parks are well maintained in general and the community looks sharp. The brick monument signs at the entrances and the parks are looking a little dated and the Board may wish to start considering replacement options. This doesn't need to happen right away but it may be a good idea to start the discussions as prominent features like may take some time for the community to come to consensus on replacement. The tennis court is ready for replacement due to tree root damage. The remainder of the community is looking in great condition especially considering the age of the community.

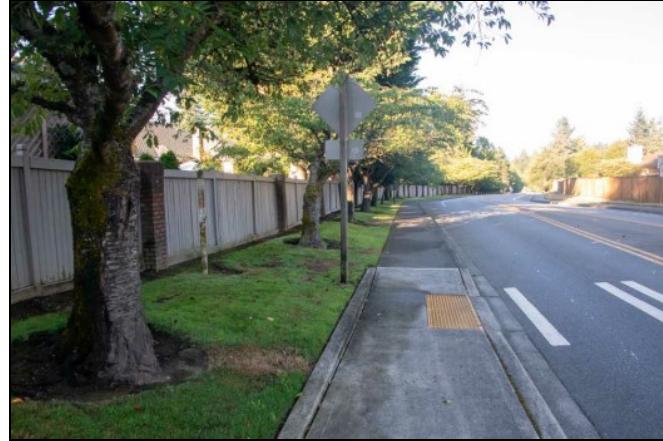
Comp #: 100 Concrete - Repair/Replace

Comments: The concrete is holding up well although aged. Root uplift is a big concern of communities of this age and should be monitored. Majority of concrete is sidewalks throughout community. Observed general local cracking with evidence of past repairs in some areas from our limited visual review. The maintenance of this component belongs to the City of Federal Way.

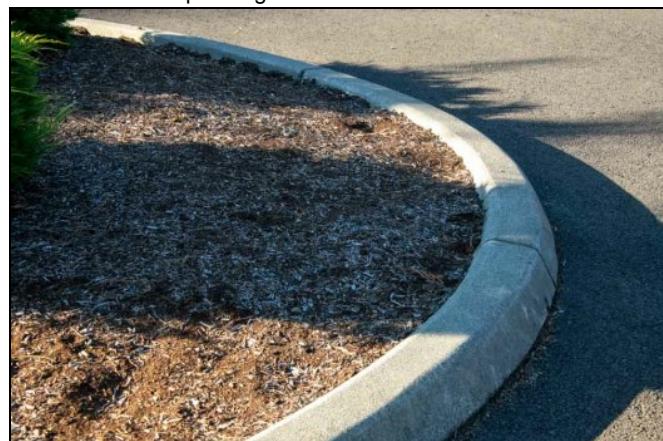
Comp #: 102 Island Curbs - Repair/Replace

History: Repaired occasionally, but no community wide replacement occurred.

This component was requested to be added by the Board as the community is in a long term process of replacing many of the curbs. At Board request, we are including funding to replace all of the traffic islands over a 30 year period. The budget allowance below provides funding for replacing 1/6 (435 LF) of the curbs every 5 years. At the end of the 30 year project, this component terminates and future repairs will be funded from operating.

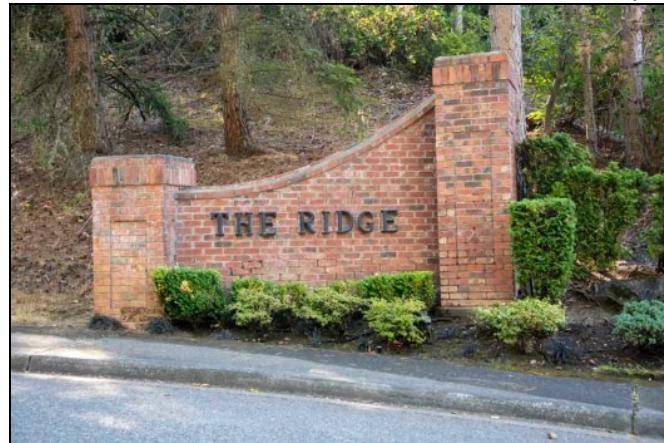
Typically brick is a low maintenance material, however, over the course of 30-40 years, mortar between bricks can become damaged or cracked and allow water to infiltrate into the walls. Although tuck pointing (grinding out small sections of existing mortar and installing new mortar) can be performed to restore, cost at this type of wall would outweigh cost/benefit of installing new monument walls. This component recommends planning for eventual complete removal and replacement of existing brick walls/lettering at the time frame shown here due to deterioration that will result from constant exposure and for aesthetic updating.
